**NATIONAL AIRCRAFT APPRAISERS ASSOCIATION
CERTIFIED APPRAISAL REPORT**

**1990 KING AIR C90A NXXXXX
PREPARED FOR AIR APPRAISAL COMPANY**

NATIONAL AIRCRAFT APPRAISERS ASSOCIATION
AIRCRAFT APPRAISAL REPORT

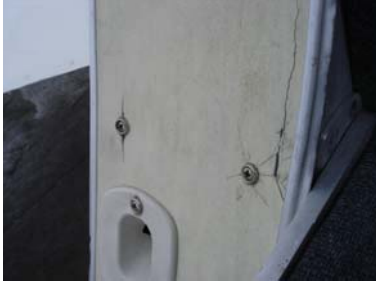
FIGURE 1

The entry door fits flush with the fuselage when closed. The door seal is in very good condition. The door latches operate smoothly and engage properly. The door stairs are in average condition, showing some wear. There are cracks present in the plastic door trim around some of the screw heads (figure 1). The door cables are secure and in good condition.

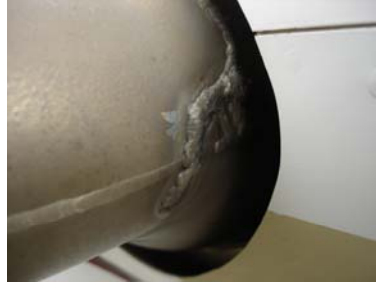
FIGURE 2

The engine nacelles are in good condition with no damage present. All access doors are secure and flush. There are no fluid leaks noted around either engine. The exhaust stacks are secure and in good condition. The inboard exhaust stack on the left engine has been repaired with welding (figure 2). The prop spinners are polished and in excellent condition. The props are in good condition, with no significant nicks or dents in the leading edges. The paint is well worn from the prop leading edges, however (figure 3). The engine air inlets are in good condition and are unobstructed.

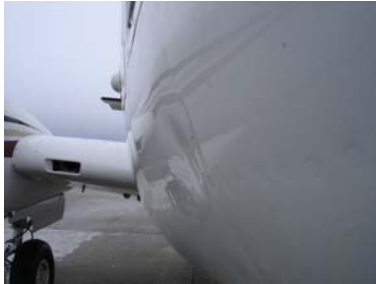
FIGURE 4

All antennae and static wicks are secure. With the exception of a very small dent on the right side nose (figure 4), likely caused by shedding prop ice, there is no evidence of present damage. Past damage repairs appear to have been professionally done, leaving no easily visible indication of the repairs made. Upon a visual, cursory inspection, there is no indication of surface corrosion on any aircraft surface.

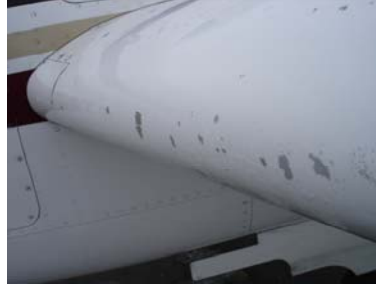
FIGURE 5

Although the paint is in nice condition overall, there are numerous areas where the paint is worn. The wing leading edges show abrasion wear (figure 5). There are small areas of peeling paint on the wing trailing edges (figure 6). The paint is worn around many of the screwheads throughout the airframe (figure 7). The paint on the upper and lower wing surface shows discoloration aft of the engine exhaust stacks, which is common for this King Air model.

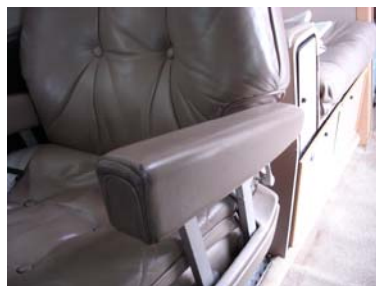
FIGURE 8

The seats are in good condition with no tears or stains present. The seams are straight and tight. The armrests are slightly worn (figure 8). The seatbelts are in good condition. The carpet is in average condition, showing some wear in the form of frayed edges and slight compaction along the aisle. The headliner is in excellent condition. The sidewalls are in very good condition except near the entry door, where the sidewall is separating slightly from the airframe (figure 9). The writing tables are in very good condition, and they extend and stow smoothly and easily. The tintable cabin windows are in good condition with no significant scratches present.
